US PUBLIC LAND SURVEY MONUMENT RECORD-ADDENDUM

TIE SHEET ADDENDUM-21505080000 (LA CROSSE COUNTY INDEX 61A)

SECTION 8 T. 15 N., R. 5 W.

LA CROSSE COUNTY, WI.

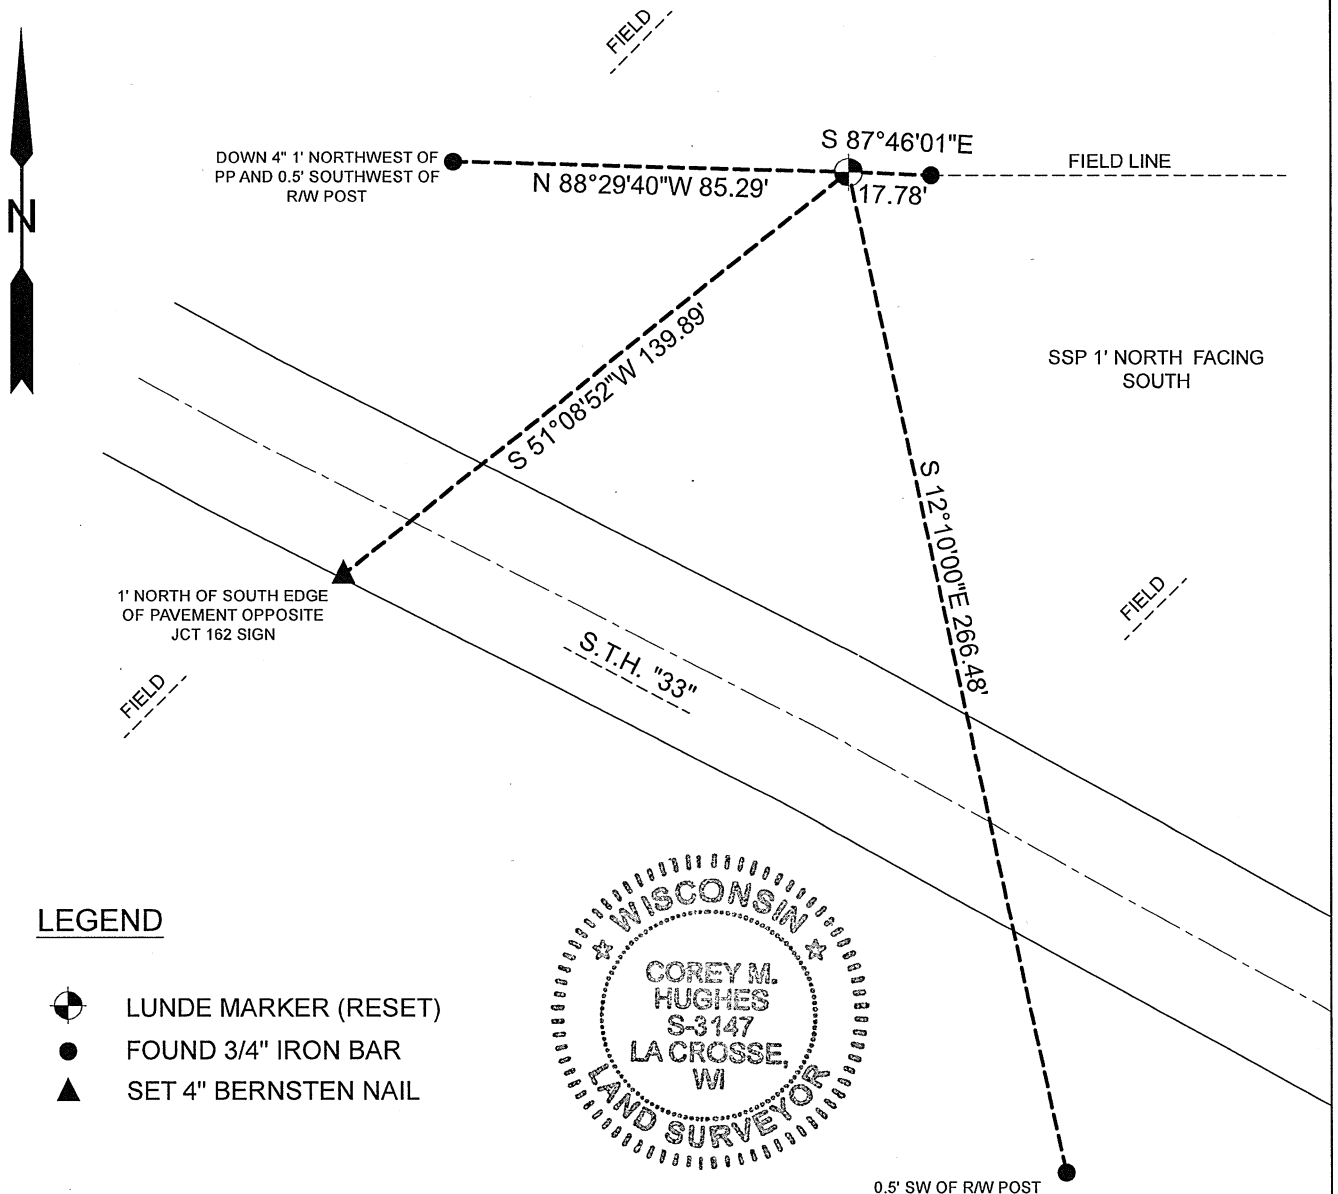
Bryan Meyer and I performed maintenance on this corner on November 15, 2018. We found the Lunde Marker leaning. We reset the Lunde Marker at the previously found location and mounded with dirt and rocks. We found 1 of W. Jung's ties and established 3 new ties as shown below.

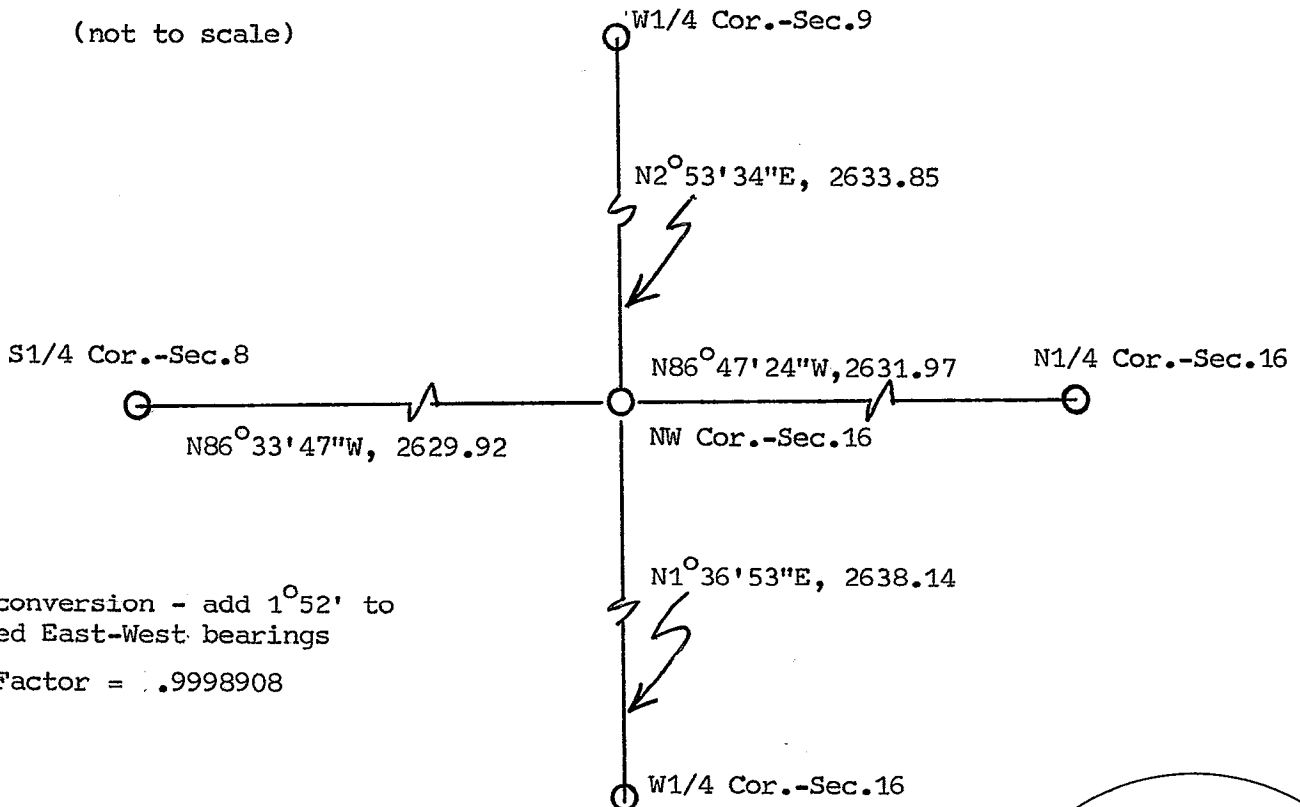
MAP SHOWING DISTANCE AND DIRECTION TO OTHER PUBLIC LAND SURVEY CORNERS USED FOR REESTABLISHING THE CORNER

I measured the distance between the North fence at the South 1/4 Corner of Section 8 and the S1/16-SE Corner of Section 8 (there being an old North fence here also). I then set this section corner at a distance from said S1/16-SE Corner equal to the previous measured "40" distance (1315'+) and in the old East-West fence line. The South line of the SE1/4 of Section 8 and the North line of the NW1/4 of Section 16 fit the original notes proportionally almost perfectly. The 1/2 miles North and South also fit very well. With the corner set as such, the West 1/4 Corner of Section 16 is only 9" off line. I set a brass capped Lunde marker at my computed corner.

I do not agree with the 1" iron bar found to the East if that iron bar was intended to be the corner.
