US PUBLIC LAND SURVEY MONUMENT RECORD-ADDENDUM
 TIE SHEET ADDENDUM-21505080020 (LA CROSSE COUNTY INDEX 62A)

SECTION 8 T. 15 N., R. 5 W.
 LA CROSSE COUNTY, WI.

TOWN OF WASHINGTON

MAINTENANCE- PUBLIC LAND SURVEY MONUMENT RECORD

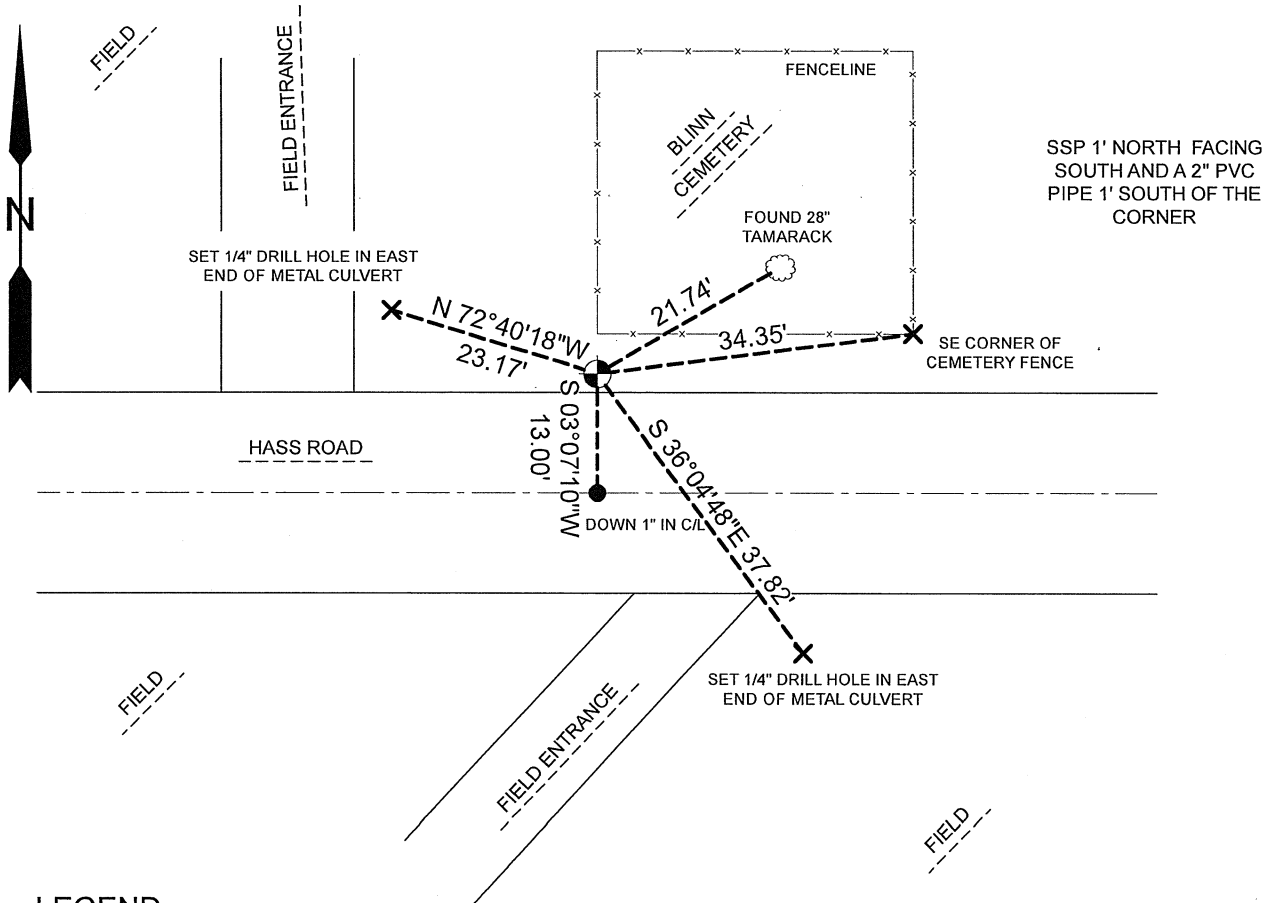
Bryan Meyer and I performed maintenance on this corner on November 15, 2018. We found the 2-3/8" O.D. Iron Pipe leaning westerly after the land owner to the Northwest called us after doing grading in the area. We reset the Iron Pipe at the previously found location. We found that the westerly fenceline of the Cemetery is now leaning and did not reuse the stone fence corner. We found 3 of W. Jung's ties and established 2 new ties as shown below.

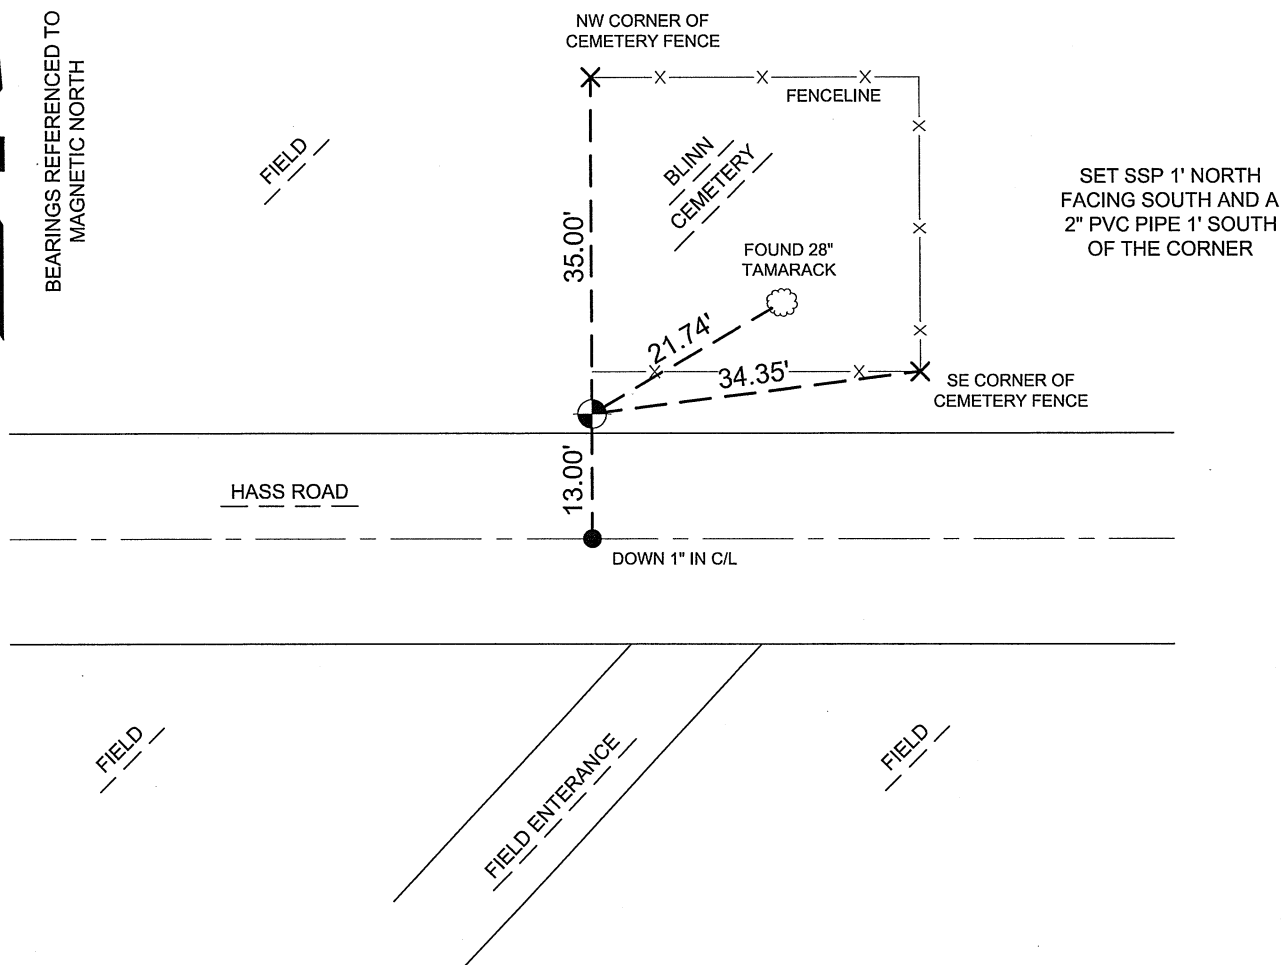
BEARINGS REFERENCED TO
MAGNETIC NORTH

I performed maintenance work for this corner on July 1, 2014 after getting an email from the Town of Washington patrolman, Tom Meyers. Tom indicated that he had struck and damaged the pipe. I found the pipe leaning with a large gash about 3" from the top. I removed the pipe and reset it with the damaged end down using the found iron bar (13.00') and the nail in a tamarack tree (21.74'). I laid a large stone to the SW and NE of the pipe and piled dirt around it. I found all of W. Jung's ties and measured as shown below.

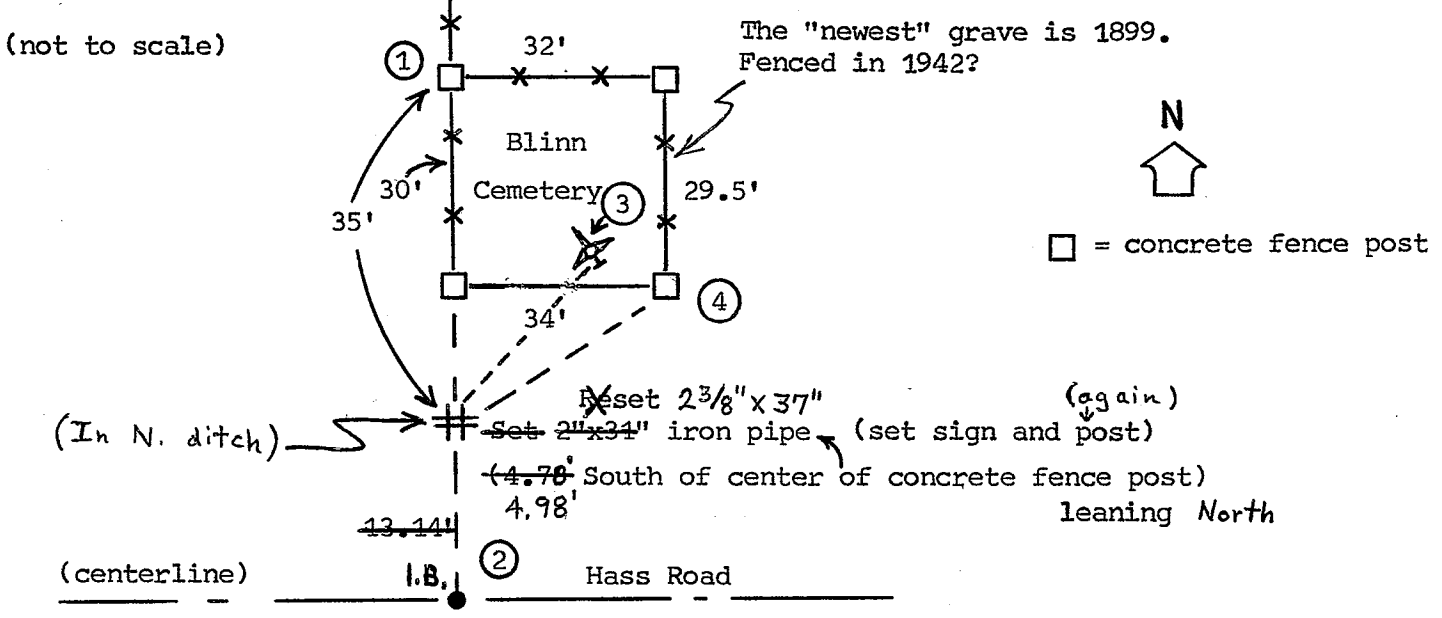
PLAN VIEW DRAWING OF REFERENCE TIES

If the P.K. nail 13.14 feet to the South in the road is intended to be the corner, I do not agree with it.

5/2/00 We reset the pipe which had been knocked out.
8/6/08 " set a " .
