# US PUBLIC LAND SURVEY MONUMENT RECORD- ADDENDUM TIE SHEET ADDENDUM-21505112000 (LA CROSSE COUNTY INDEX 50A)

SECTION 11

TOWN OF WASHINGTON

LA CROSSE COUNTY, WI.

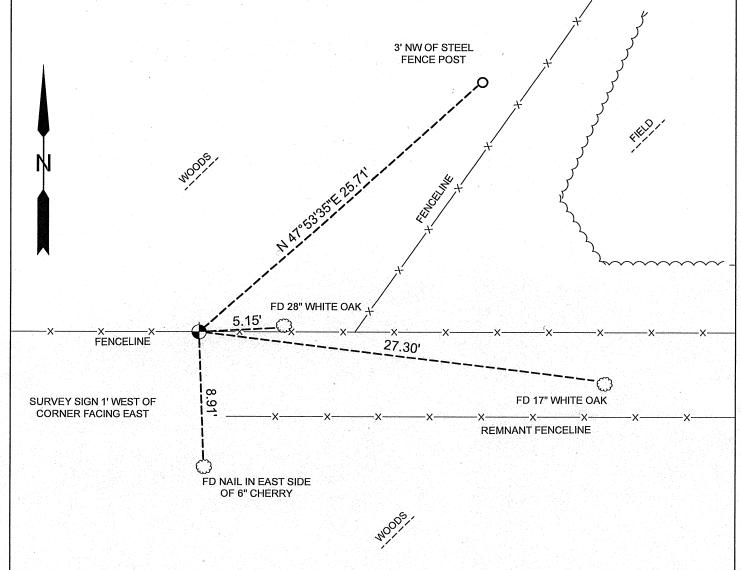
March 11th, 2020- Bryan Meyer and I performed maintenance on this corner and found the 3/4" Iron bar with aluminum cap under fenceline at the corner. I also found 3 of C. Fechner's ties and established 1 new tie as shown below.

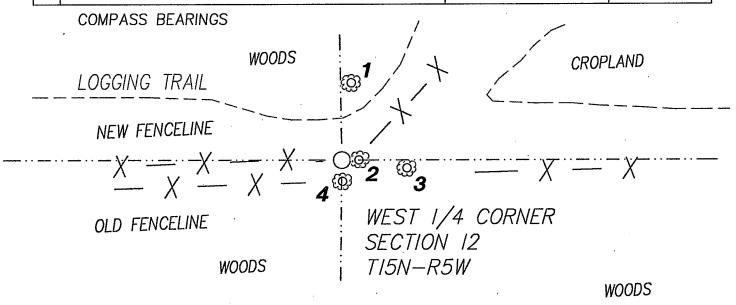
## PLAN VIEW DRAWING OF REFERENCE TIES

· We found a stong East — West fenceline and a diagonal fenceline that terminates very near the calculated corner. The area was searched for original B.T.'s and any unrecorded stones. We found nothing except ancient fenceline and piles of old fence posts near the corner location.

I set the corner 10.63' South of the Midpoint distance in an existing fenceline. The corner is 37 feet East of the straight line distance.
