US PUBLIC LAND SURVEY MONUMENT RECORD-ADDENDUM

TIE SHEET ADDENDUM-21505080000 (LA CROSSE COUNTY INDEX 61A)

SECTION 8 T. 15 N., R. 5 W.

LA CROSSE COUNTY, WI.

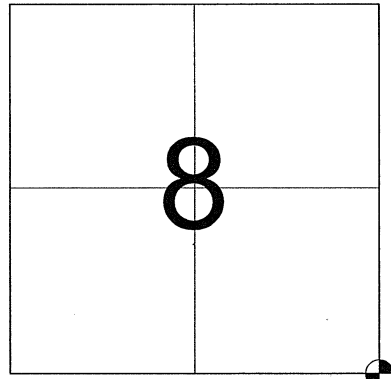
LOCATION OF LANDMARK

Bryan Meyer and I performed maintenance on this corner on November 15, 2018. We found the Lunde Marker leaning. We reset the Lunde Marker at the previously found location and mounded with dirt and rocks. We found 1 of W. Jung's ties and established 3 new ties as shown below.

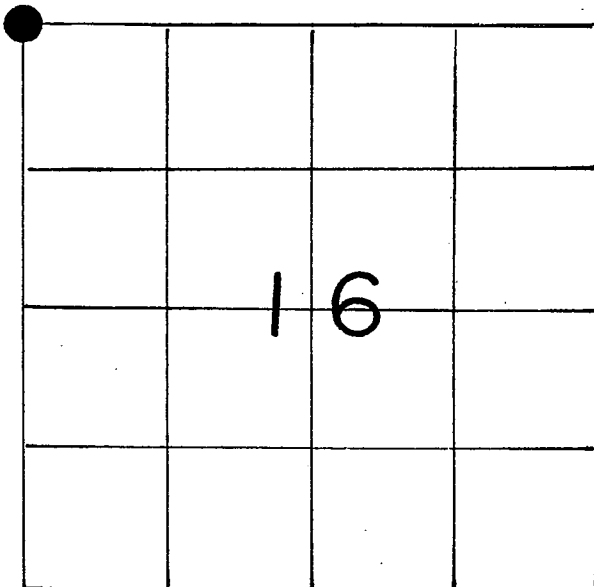
LOCATION OF LANDMARK

I measured the distance between the North fence at the South 1/4 Corner of Section 8 and the S1/16-SE Corner of Section 8 (there being an old North fence here also). I then set this section corner at a distance from said S1/16-SE Corner equal to the previous measured "40" distance (1315'+) and in the old East-West fence line. The South line of the SE1/4 of Section 8 and the North line of the NW1/4 of Section 16 fit the original notes proportionally almost perfectly. The 1/2 miles North and South also fit very well. With the corner set as such, the West 1/4 Corner of Section 16 is only 9" off line. I set a brass capped Lunde marker at my computed corner.

I do not agree with the 1" iron bar found to the East if that iron bar was intended to be the corner.
