US PUBLIC LAND SURVEY MONUMENT RECORD-ADDENDUM
 TIE SHEET ADDENDUM-21505080020 (LA CROSSE COUNTY INDEX 62A)

SECTION 8 T. 15 N., R. 5 W.
 LA CROSSE COUNTY, WI.

TOWN OF WASHINGTON

MAINTENANCE- PUBLIC LAND SURVEY MONUMENT RECORD

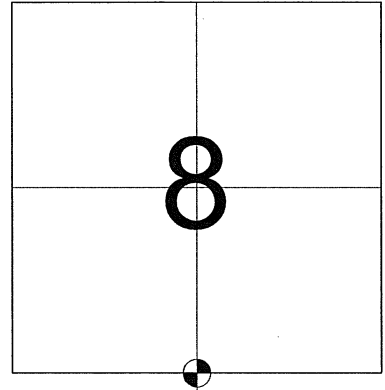
LOCATION OF LANDMARK

Bryan Meyer and I performed maintenance on this corner on November 15, 2018. We found the 2-3/8" O.D. Iron Pipe leaning westerly after the land owner to the Northwest called us after doing grading in the area. We reset the Iron Pipe at the previously found location. We found that the westerly fenceline of the Cemetery is now leaning and did not reuse the stone fence corner. We found 3 of W. Jung's ties and established 2 new ties as shown below.

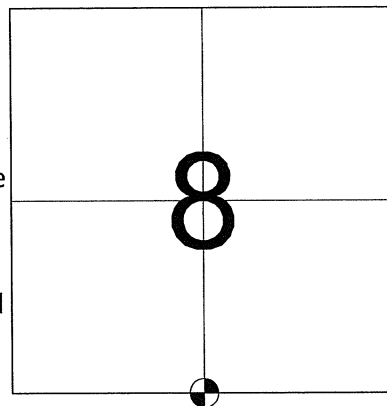
LOCATION OF LANDMARK

I performed maintenance work for this corner on July 1, 2014 after getting an email from the Town of Washington patrolman, Tom Meyers. Tom indicated that he had struck and damaged the pipe. I found the pipe leaning with a large gash about 3" from the top. I removed the pipe and reset it with the damaged end down using the found iron bar (13.00') and the nail in a tamarack tree (21.74'). I laid a large stone to the SW and NE of the pipe and piled dirt around it. I found all of W. Jung's ties and measured as shown below.

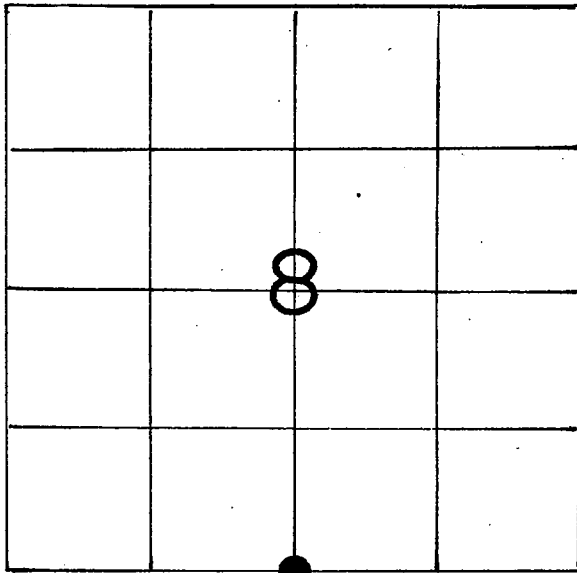
LOCATION OF LANDMARK

To the North is the old Blinn family cemetery. In 1904 Fred Blinn deeded his farm to Hundt (as described in Volume 106 Deeds, Page 53) except for a 35 ft. square parcel in the Southwest corner of the SW-SE. This parcel was reserved for burial purposes. Using this 1904 description, I set the corner by lining in with the old fence to the North and measuring 35 feet South from the NW corner of the cemetery. The cemetery fences are very old. I would assume that the location of the corner was known when the fences were built. The South fence is probably off to the North because of the highway cut. Describe or show any material discrepancy between the location of the restored corner and that of the corner previously restored or reestablished.

If the P.K. nail 13.14 feet to the South in the road is intended to be the corner, I do not agree with it.

5/2/00 We reset the pipe which had been knocked out.
8/6/08 " set a " .
