U. S. PUBLIC LAND SURVEY MONUMENT RECORD

SECTION 31 T 15 N, R 5 W, TOWN OF WASHINGTON

LA CROSSE COUNTY

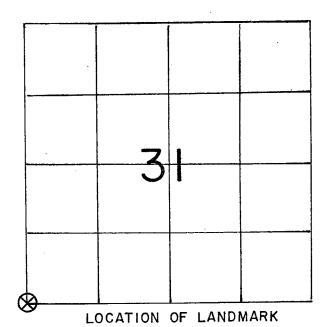
NO		BEARING	DISTANCE	
1	Fd. Set 1-3/4" x 16" Iron Pipe	Northwesterly <u>+</u>	-20.76 Ft.	2
2 -	Previously set P.K. Nail in center of cattle	pass. N 84 ⁰ 20*40" E	23.37 Ft.	2
3	NW-Corner of concrete deck curbing	Easterly <u>+</u>	13.52 Ft.	1
4	Fd. Set 1-3/4" x 21" Iron Pipe under fence.	Southeasterly <u>+</u>	24.75 Ft.	2

(D.O.T. HORIZONTAL CONTROL STATION "MOILIEN") (Not to scale) (PASTURE) Computed Location SW-Cor., Sec. 31-15-5. (FIELD) Offset Drill Hole in bottom stone of rock retaining wall. Set sign & post to east of the corner. Offset drill hole is 57007'W. 0.35 feet from the computed 4 corner. PLAN ^{*}REFERENCE VIEW DRAWING OF

Due to time, frost, weather, etc., the drill hole at the corner in the stone retaining wall shifted to the southwest $(S7^{\circ}07^{\circ}W, 0.35 \text{ feet})$. The drill hole is now an offset point. We could not set a new corner. The corner is now a computed point. The retaining wall obviously moved since 1995.

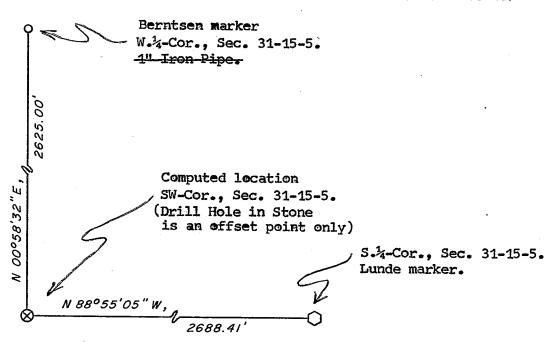
MAP SHOWING DISTANCE AND DIRECTION TO OTHER PUBLIC LAND SURVEY CORNERS USED FOR REESTABLISHING THE CORNER

(Not to scale)

According to the Moilien brothers, their grandfather said that the Town corner fell on the cattle pass. Other locals recounted the same story. One of the brothers went on to say that it did not fall in one of the four towns because one town did not want to participate in the cost. This is a four generation farm, so the Moiliens have been here for some time. The cattle pass does not fall in three or four towns, but the County line does go through it East-West. I measured a mile North, a mile East, 1/2+ mile South, and 1/4 mile West. I also tied in several forty corners. After analyzing the field evidence and comparing it against the original notes in all four towns AND against the old County surveyor notes in both counties, I set the corner at a computed****

****location that best fits the field evidence and old field notes. We drilled a hole for the corner.
